**INSTITUTE OF OCCUPATIONAL MEDICINE**  
**Research Avenue North, Riccarton, Edinburgh, EH14 4AP**

**Report to client**

**Testing carried out:** Type 6 testing in accordance with ISO 17491-4:2008, Method A Determination of resistance to penetration by a spray of liquid (spray test)

**Model tested:** Protective Coverall TTK-A01

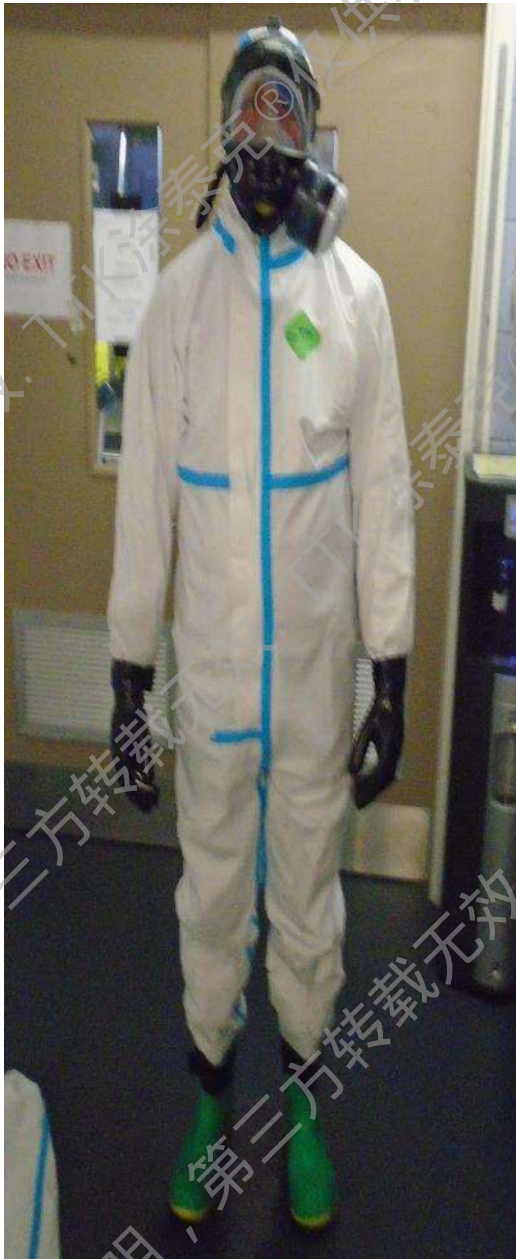
An example of a fully dressed wearer is shown below.

**Fully dressed wearer**

The device is a white material one-piece hooded coverall with blue external taped seams. The device incorporates elasticated cuffs, ankles, waist and hood. There is a single action zip at the front of the suit running from the crotch to the neck, covered during use by a white material flap which is sealed to the suit with integral double sided tape.

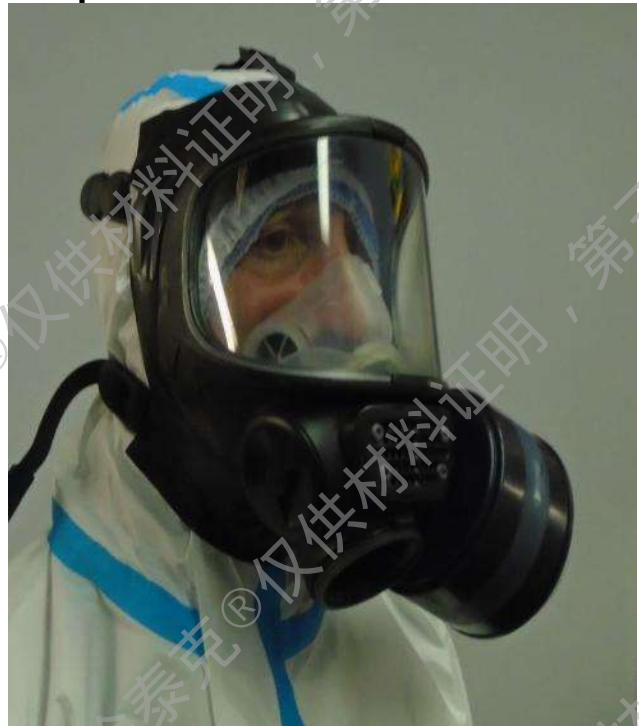
**Suit worn with Scott "ProMask" facepiece**

At the request of the client the coveralls were taped, using 50 mm wide PVC electrical insulating tape, onto chemical resistant gloves, wellington boots and a Scott "Promask" facepiece.
